NAVAL AVIATION SAFETY CENTER
NAVAL AIR STATION
NORFOLK, VIRGINIA 23511

Subj: NARTU Alameda AAR ser 4-68A concerning A-4A BuNo 142160
accident occurring 14 January 1968, pilot COVILL

PART VI: DAMAGE TO THE AIRCRAFT

PART VII: THE INVESTIGATION

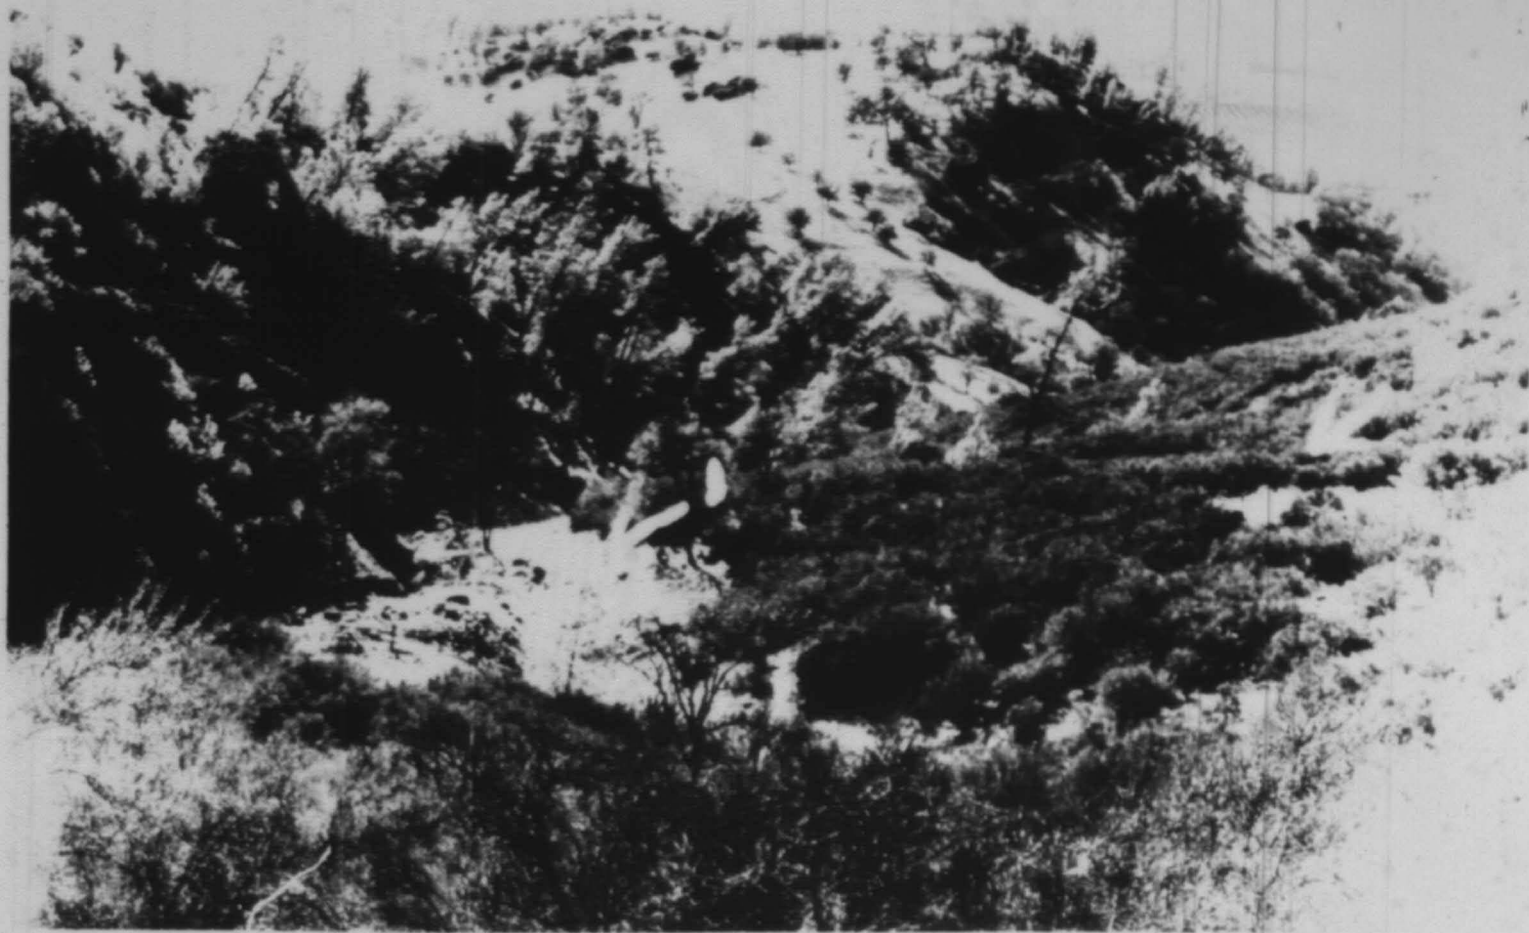
Enclosure (2), Photo #4 to
 NARTU Alameda AFB Serial 3-65A
 and 4-65A, involving A1A BEND's
 142160/137817, occurring 14 Jan
 1968, pilots COWILL & MEADER.
 Oblique view of crash site
 looking back down flight path.
 Note (1) Impact point LCDR
 MEADER's aircraft, (2) Impact
 point LCDR COWILL's aircraft.
 SPECIAL HANDLING REQUIRED IN
 ACCORDANCE WITH ONYX INST
 3750.6F
